## ArmorGalv® for nails

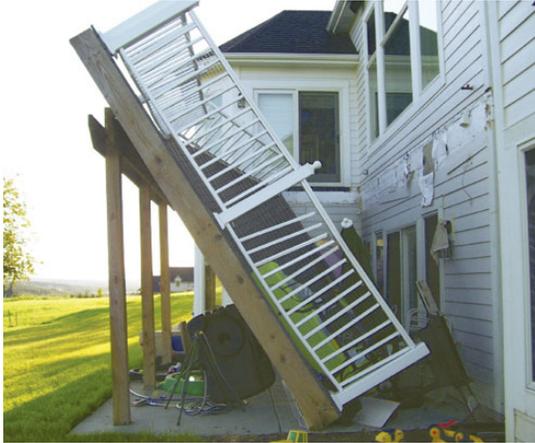
Typical deck collapse due to corroded fasteners

Many of the structural failures, and particularly roof failures, in hurricanes and other storms, are due to corroded fasteners, no longer able to hold structures in place.

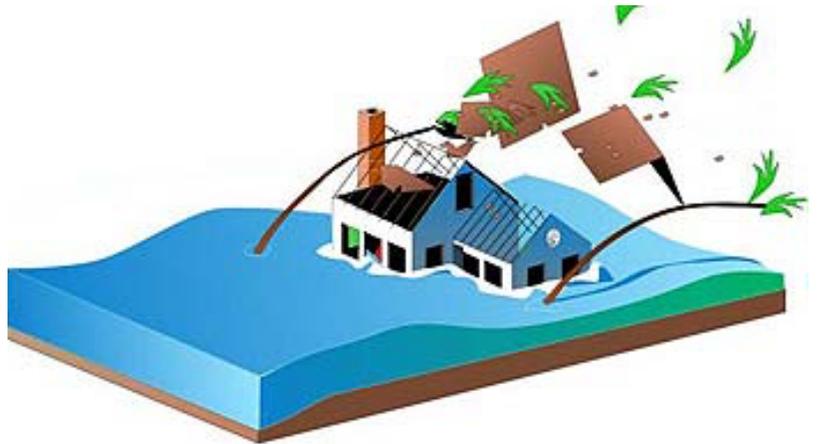
This is what happens in a storm, if fasteners corrode and no longer have the holding power required to hold the roof in place.

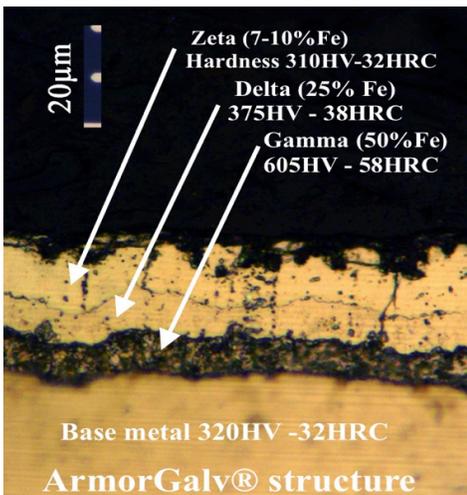
**ArmorGalv®** Cross section

*M6 cap head screw with captive washer*

**ArmorGalv®** is not merely a sacrificial coating. It diffuses zinc atoms into the surface of any steel part, creating a zinc/iron alloy, which has proven to last decades in the most severe environments.

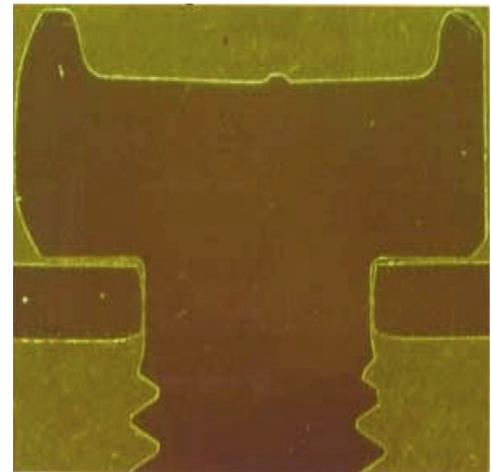
Cross section of cap screw showing precision and uniformity of coating

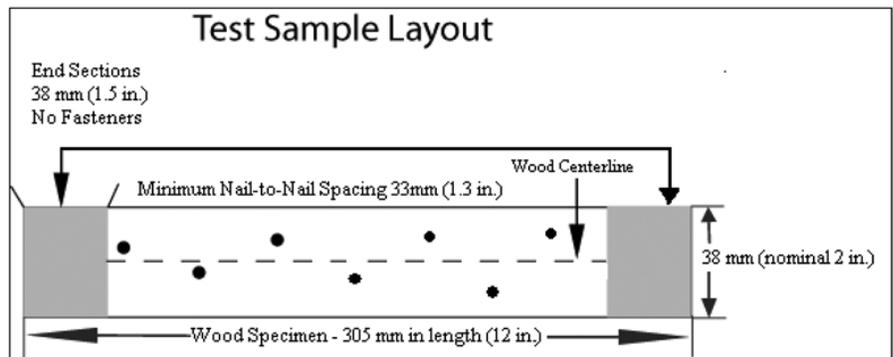
Wood test sample with driven nails is exposed to a cyclic salt test for 120 days. This is a far more severe test than the procedures used up to now.

Driving nails into wood with a nail gun, or even by hand, exerts a great deal of friction on the coating and will cause most coatings to be damaged or scraped off. Since **ArmorGalv®** is a zinc iron alloy, with a surface hardness of 31 HRC, rather than a coating, it does not get damaged during the driving process.
