# DSI Australia: Newly developed Mesh Express Plate prevents Sparking in Mines

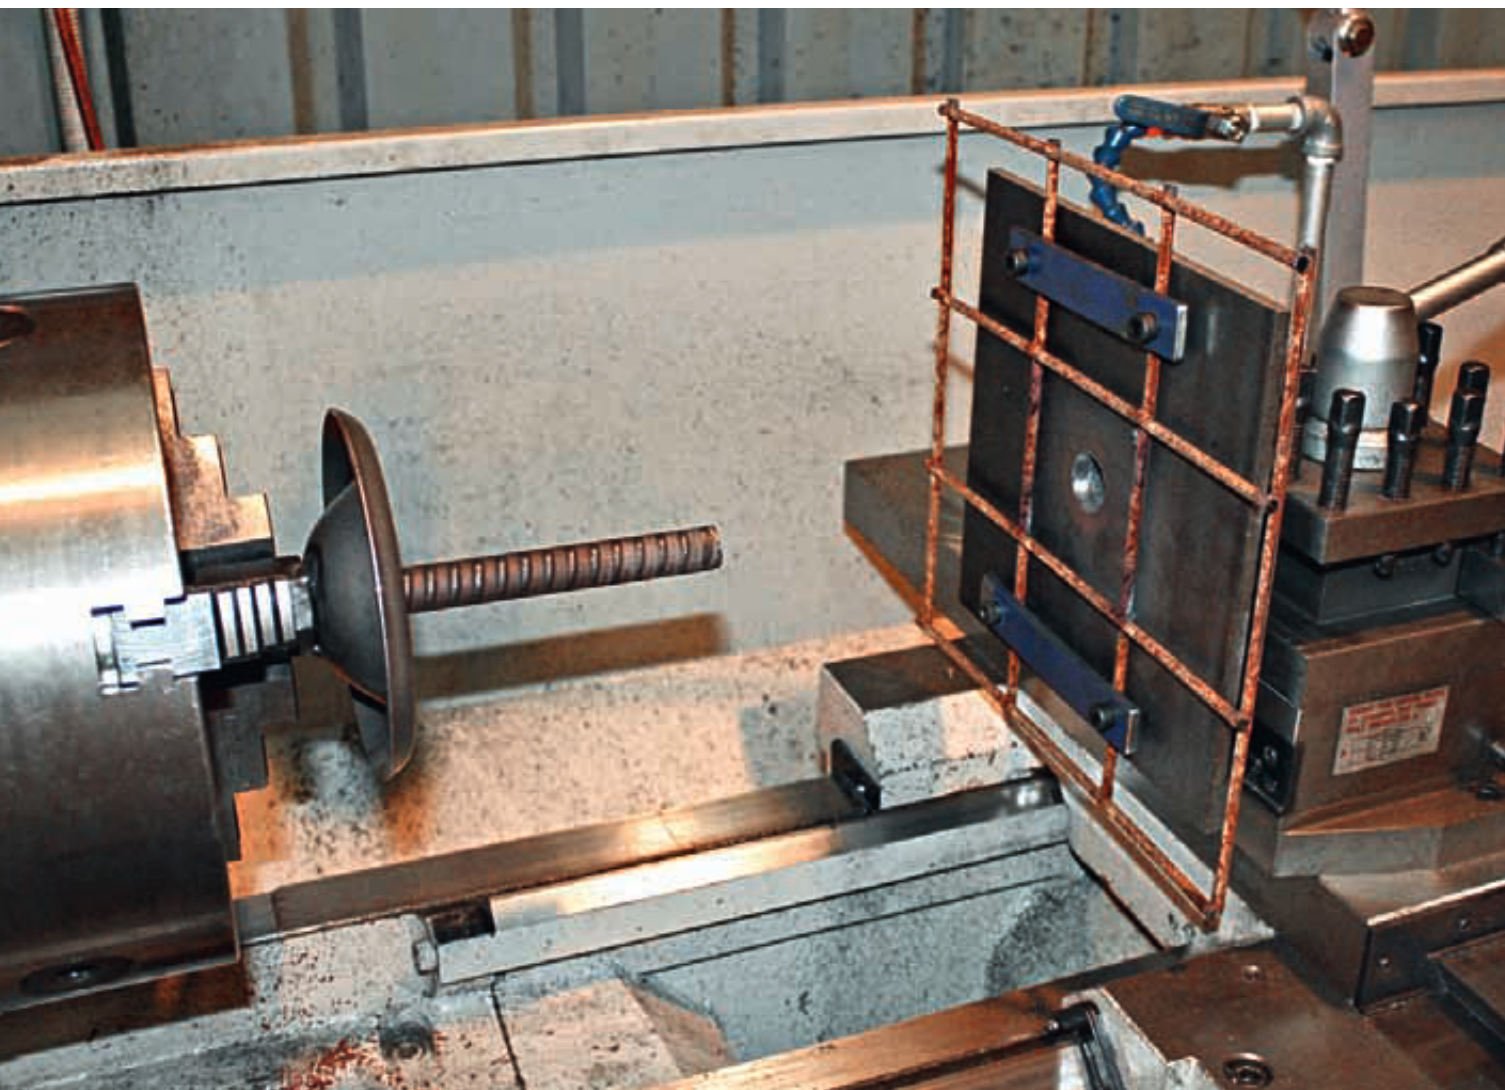
Test Mock-Up

A test setup to simulate the rotation speed of the plate and possible contact velocities as well as durations of contact was done in a safe environment. A thermal diffusion galvanizing process called Armorgalv was used as a surface coating because of its ability to coat without binding up the thread paths. This galvanized coating and a combination of **Armorgalv** and powder coated paint was tested on the Mesh Express Plates in order to determine their influence on spark formation.

The testing conducted gave a clear indication of how much each coating reduced sparking under medium load with high speed contact.

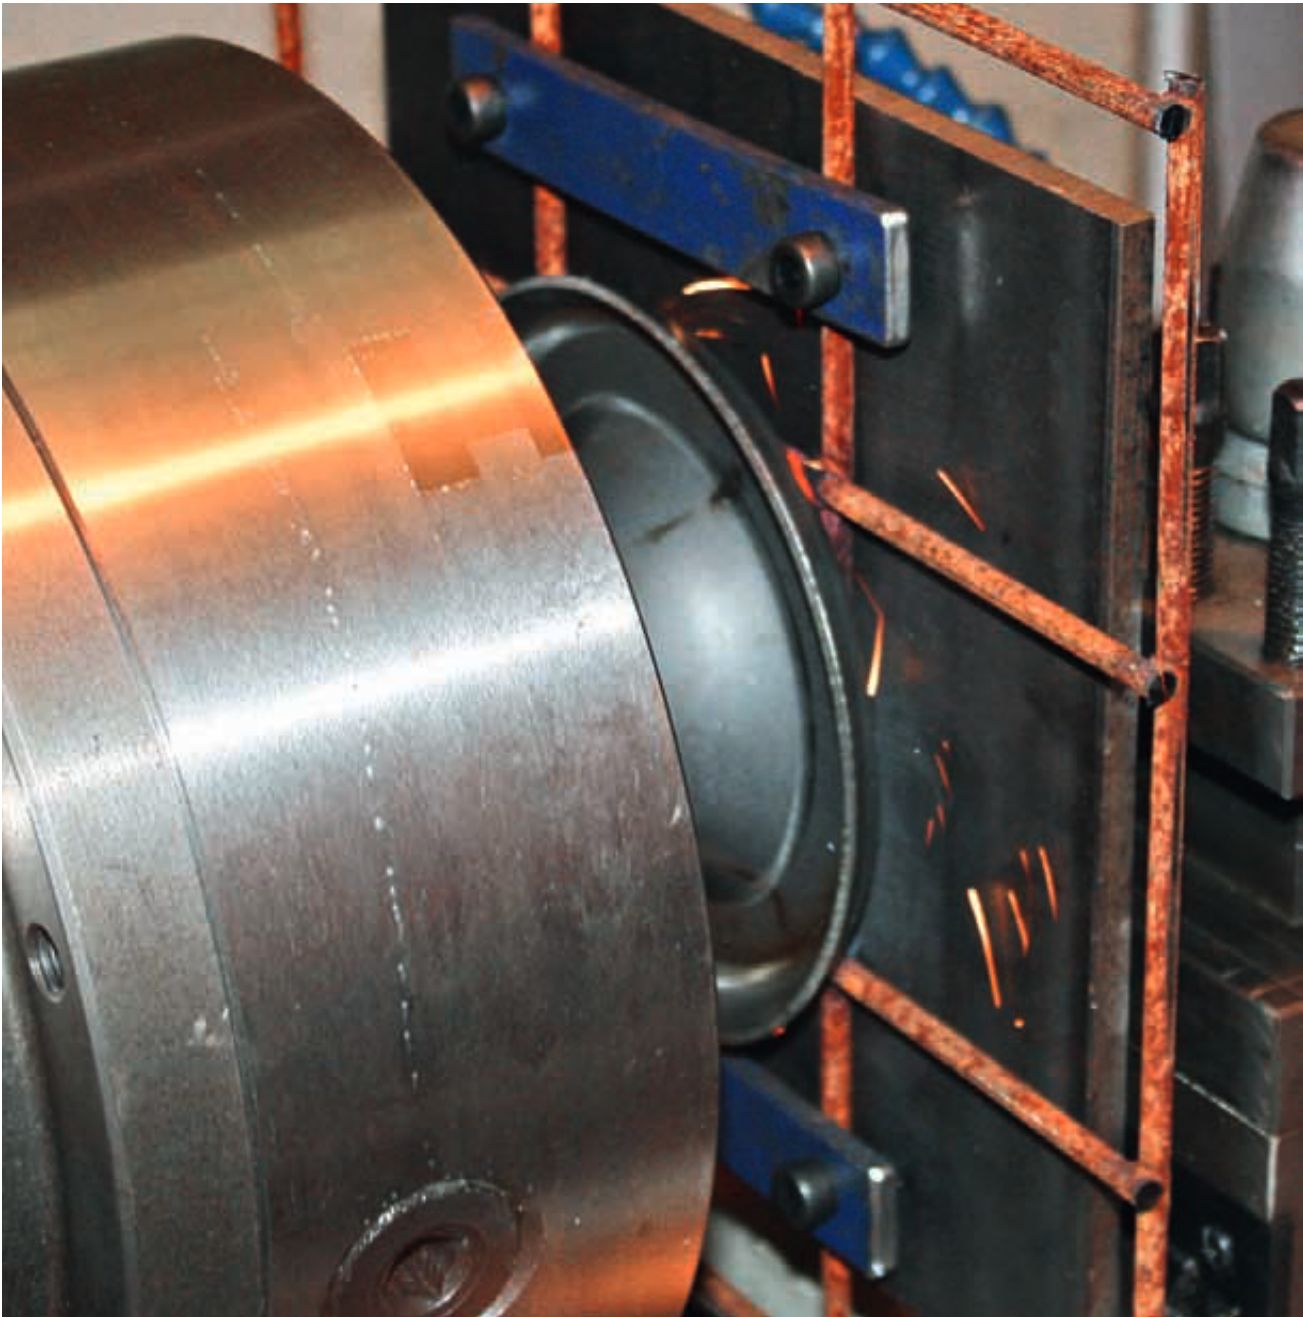
Sparking at high Rotation

During a DSI visit to an underground mine site in Australia, a rare event of sparking was observed during mesh installation operations as a steel mesh plate was installed on a rock bolt at a high degree of rotation velocity and spun up against non galvanized mesh.

Sparking was virtually eliminated when at least one surface of the anchor plate had a galvanized coating. The powder coated paint further reduced the amount of sparking generated, but did lead to the paint smoking from the friction heat.

Solid Energy introduced the **Armorgalv** coated Mesh Express Plates within a week of the lab testing with no further incidents of sparking noted by production personnel. The old uncoated plates were eliminated from the work site as a further precaution during the changeover.
