# PERFORMANCE REPORT

**Test Method:**  
**Miami-Dade County Protocol TAS 114, Appendix E (1995)**

**Products:**  
**Roofing and Sheathing Nails**

## REPORT OF TEST

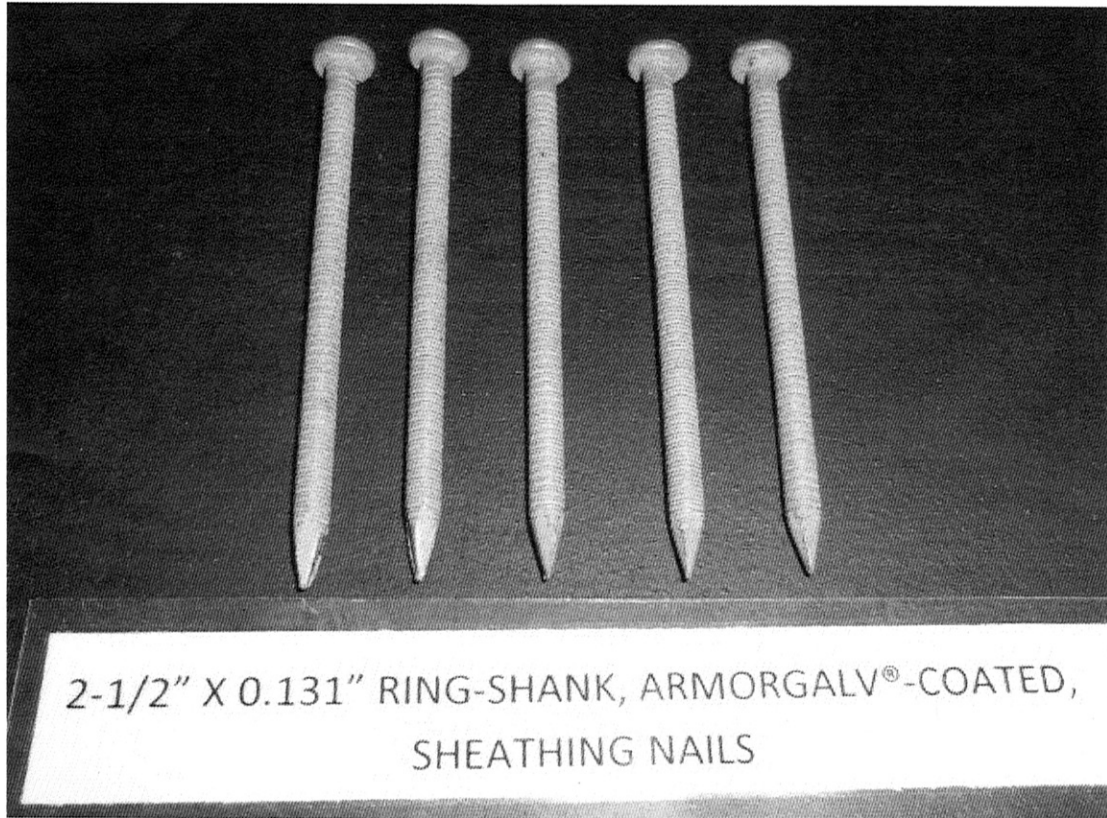
**Photograph 2**  
**2-1/2" x 0.131" Ring-Shank, Armorgalv®-Coated, Sheathing Nails (Before)**

- 8.5 This report was reissued on 01/19/15 to correct two (2) errors in the report.
- 8.5.1 The caption of Photograph 2 on Page 5 incorrectly identified the nails as "Electrogalvanized." The caption was corrected to identify the nails as "ArmorGalv<sup>®</sup>-Coated."

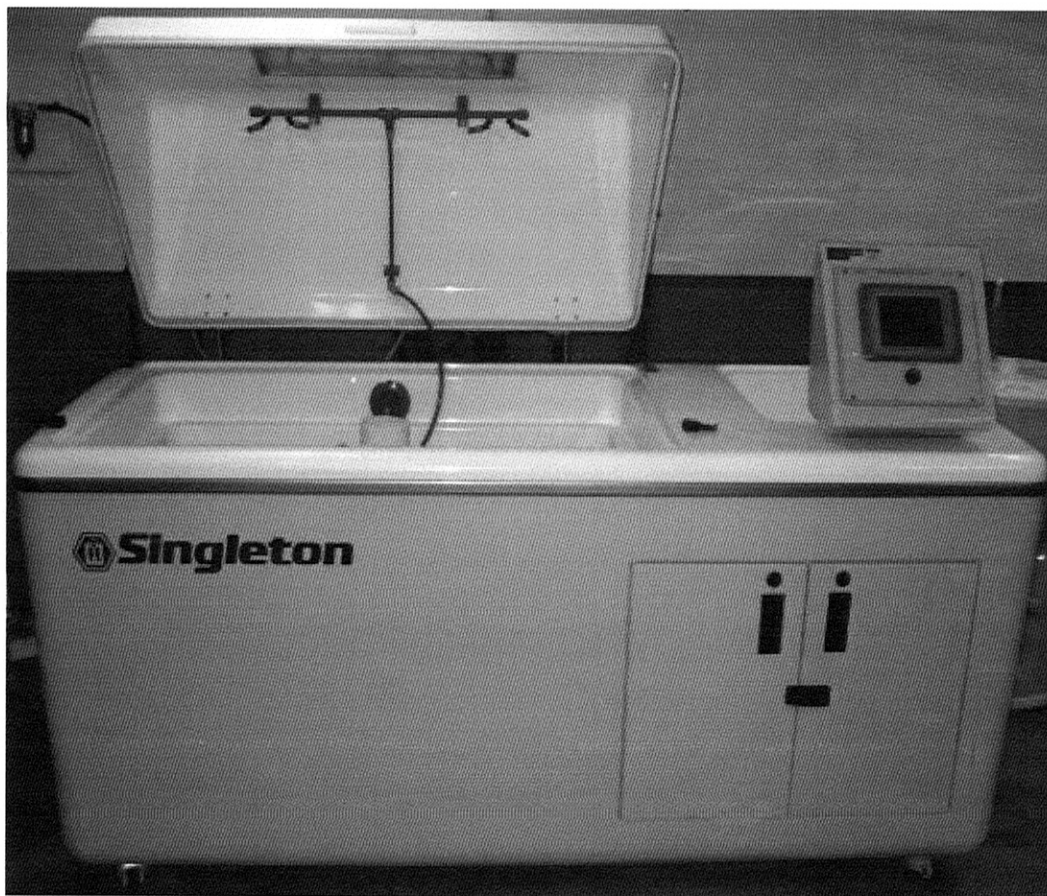
**Photograph 3**  
**Cyclic Corrosion Test Chamber**

- 3.1 Cyclic Corrosion Test Chamber – The ARL Cyclic Corrosion Test Chamber was utilized to accommodate the parameters of TAS 114, Appendix E, for the purpose of testing the nails and tin tabs. The Chamber, Model CCT10-MB-8AD, was manufactured by Singleton Corporation. The sample space volume is 21 ft<sup>3</sup>. The inside dimensions are 48 x 33 x 24 inches. The Chamber has a temperature range of ambient - 140°F and a humidity range of ambient - 100%.

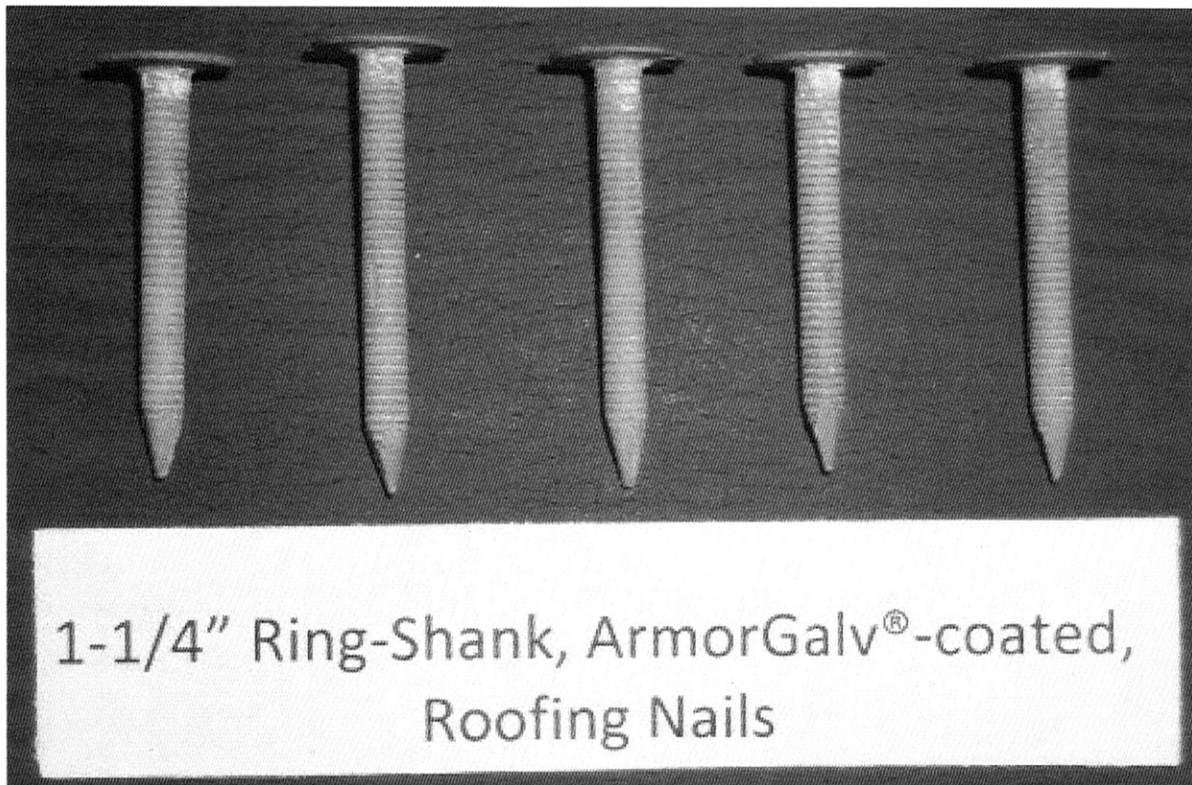
**Photograph 5**  
**1-1/4" Ring-Shank, ArmorGalv®-Coated, Roofing Nails (After)**

- 6.1 An objective visual examination was conducted on each specimen according to the guidelines of TAS 114, Appendix E, Section 2.6.1.1.
- 6.2 The acceptance criteria is defined as any test specimen that exhibits corrosion on an area in excess of 5% of its total surface area shall be considered as failing this test.
- 6.3 Based on the acceptance criteria the following conclusions were made:

Product	Status
1-1/4" Ring-Shanked, ArmorGalv <sup>®</sup> -Coated, Roofing Nails	PASS
2-1/2" x 0.131" Ring-Shanked, ArmorGalv <sup>®</sup> -Coated, Sheathing Nails	PASS

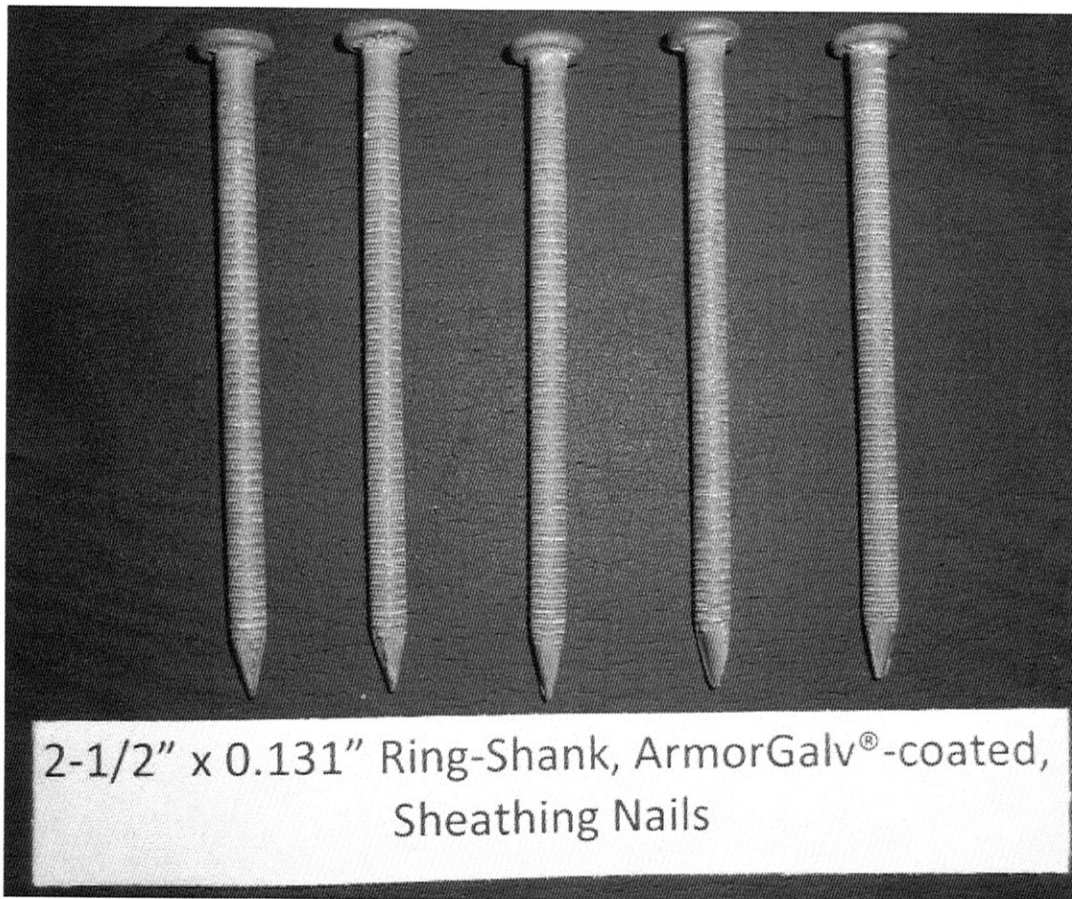
**Photograph 6**  
**2-1/2" x 0.131" Ring-Shank, ArmorGalv®-Coated, Sheathing Nails (After)**

- 8.5.2 The caption of Photograph 6 on Page 10 incorrectly identified the nails as "Electrogalvanized." The caption was corrected to identify the nails as "ArmorGalv<sup>®</sup>-Coated."
